TECHNICAL REPORT SL-83-6

# AN EVALUATION OF THE SEPARATED BAY CONCEPT FOR A MUNITION ASSEMBLY COMPLEX; AN EXPERIMENTAL INVESTIGATION OF THE DEPARTMENT OF ENERGY BUILDING 12-64 COMPLEX

Structures Laboratory

Prepared for Department of Energy, Albuquerque Operations  
Amarillo Area Office, Amarillo, Texas 79120

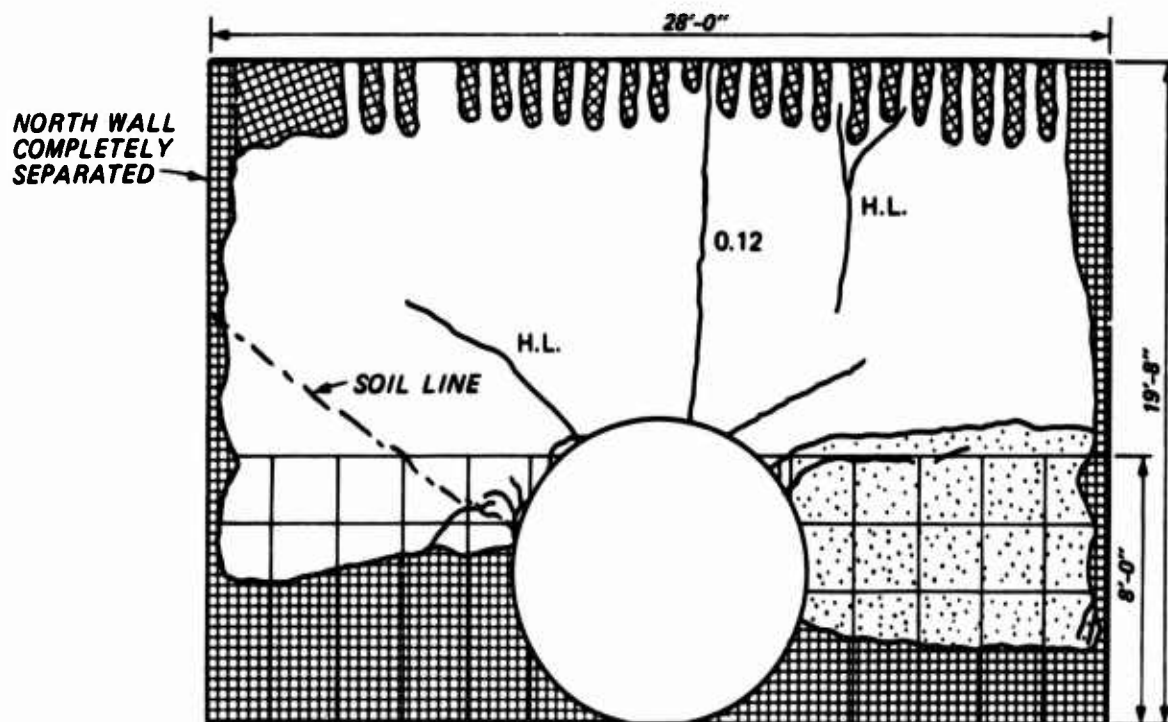
Figure 4.13. Posttest damage to east donor bay wall.

NOTE: CRACK DIMENSIONS IN INCHES  
SIX #5 DOWELS REMAINED IN TOP OF WALL

- INNER FACE REINFORCEMENT EXPOSED DUE TO WALL ROTATION
- FRAGMENTED BUT NOT SPALLED
- REBAR PULLED OUT OF CONCRETE
- H.L. HAIRLINE CRACKS

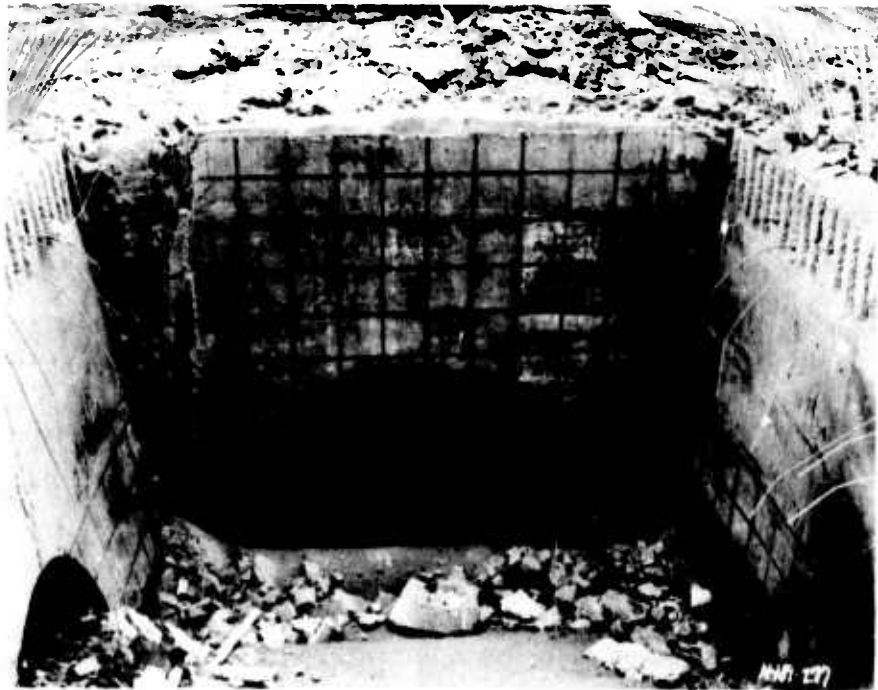
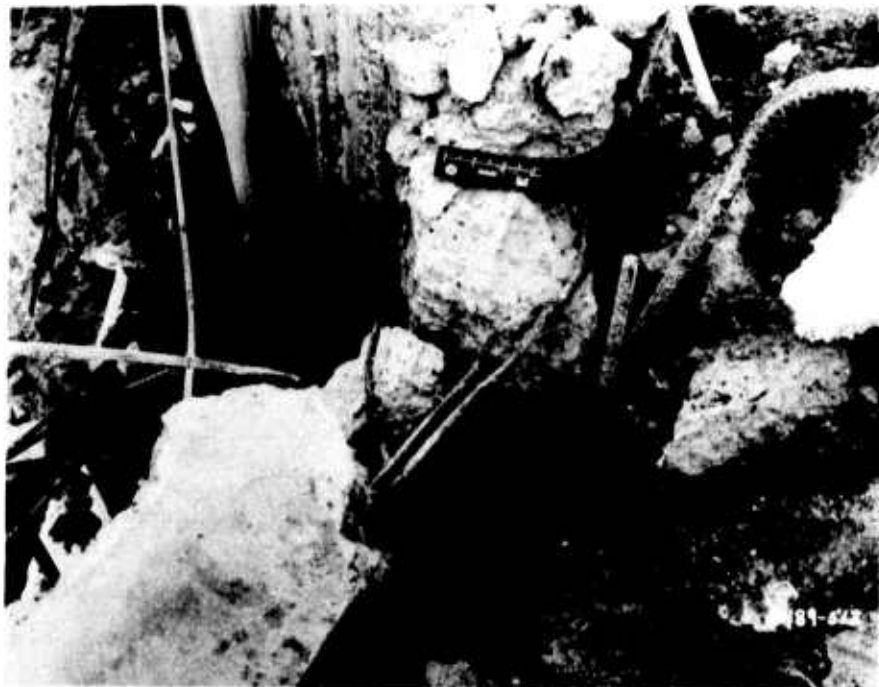
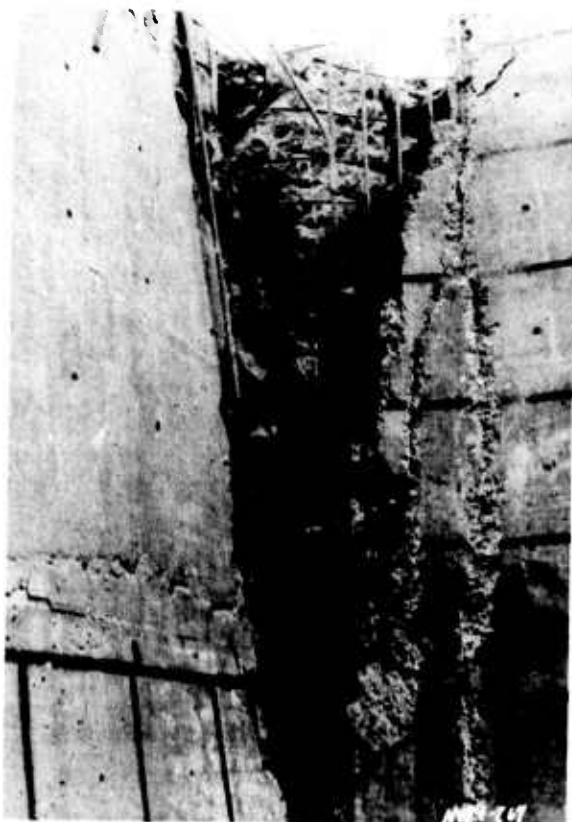
Figure 4.14. Posttest damage to donor bay south wall (Sheet 1 of 3).

a. Overall view.

b. Exterior of southeast corner.

c. Upper interior view of southeast corner.

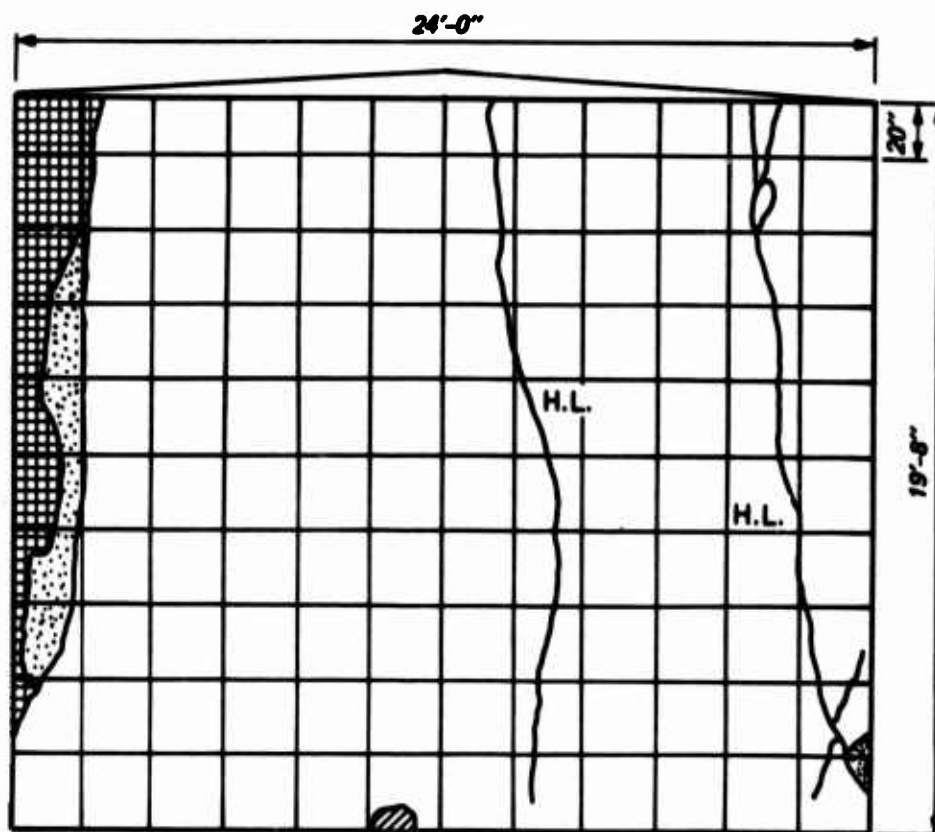
Figure 4.15. Posttest damage to south donor bay wall.

NOTE: CRACK DIMENSIONS IN INCHES

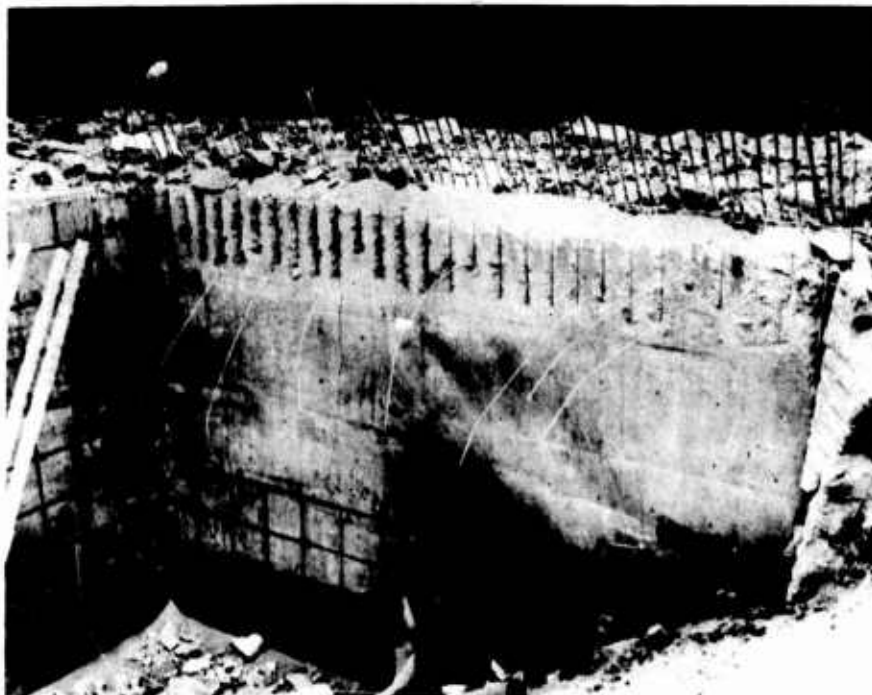
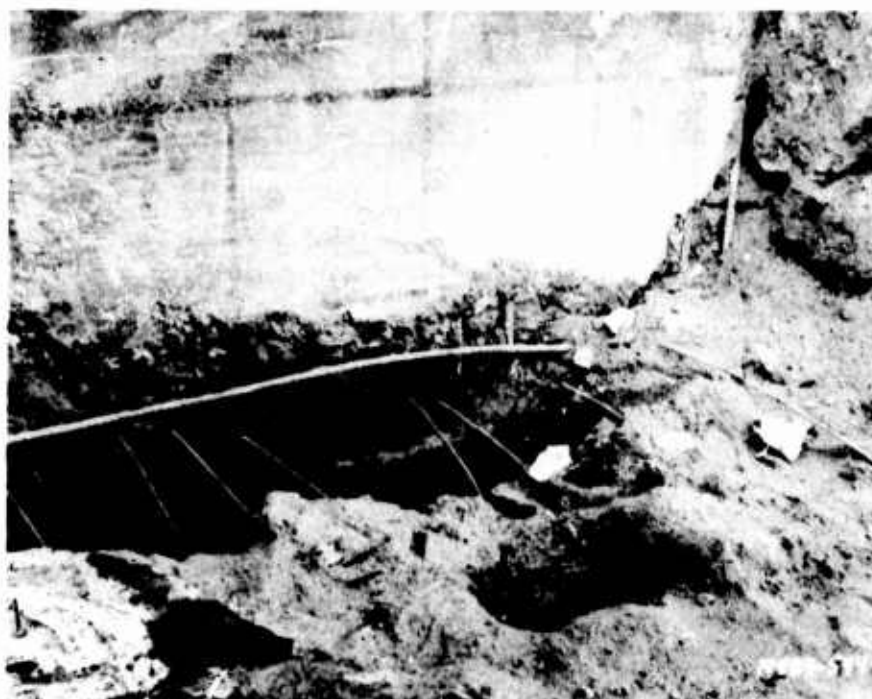
Figure 4.16. Posttest damage to west donor bay wall.

a. Overall view.

b. Base of wall at the north end.

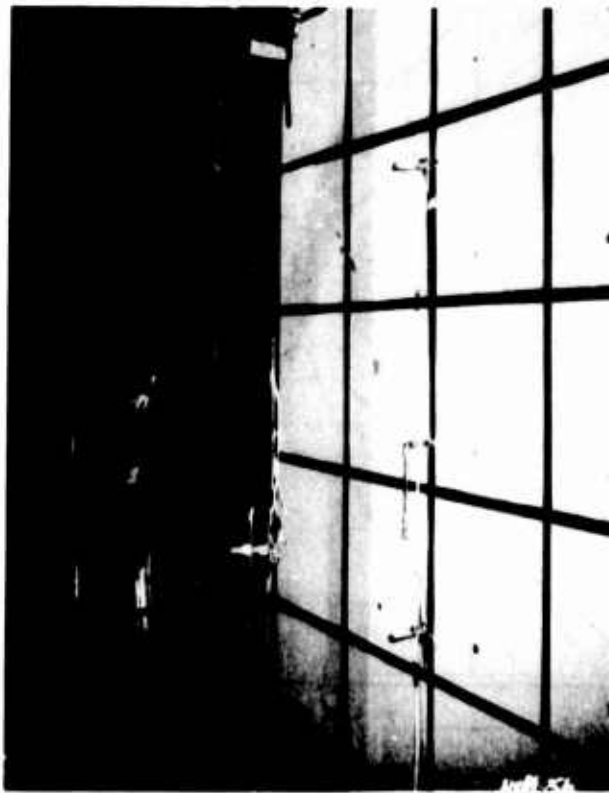
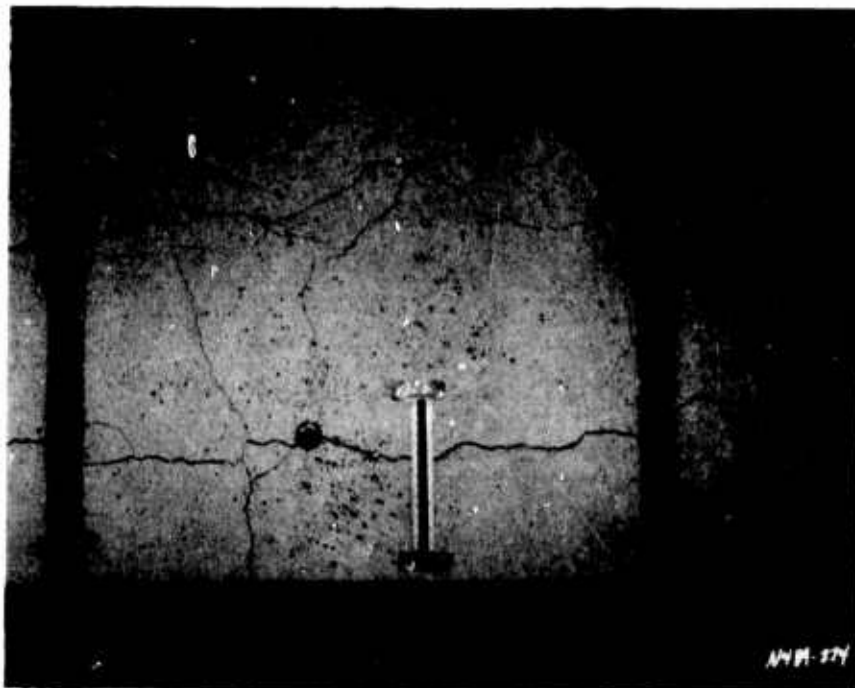
Figure 4.18. Posttest view of acceptor bay south wall.

a. Central portion of wall.

b. Detail of widest cracks.

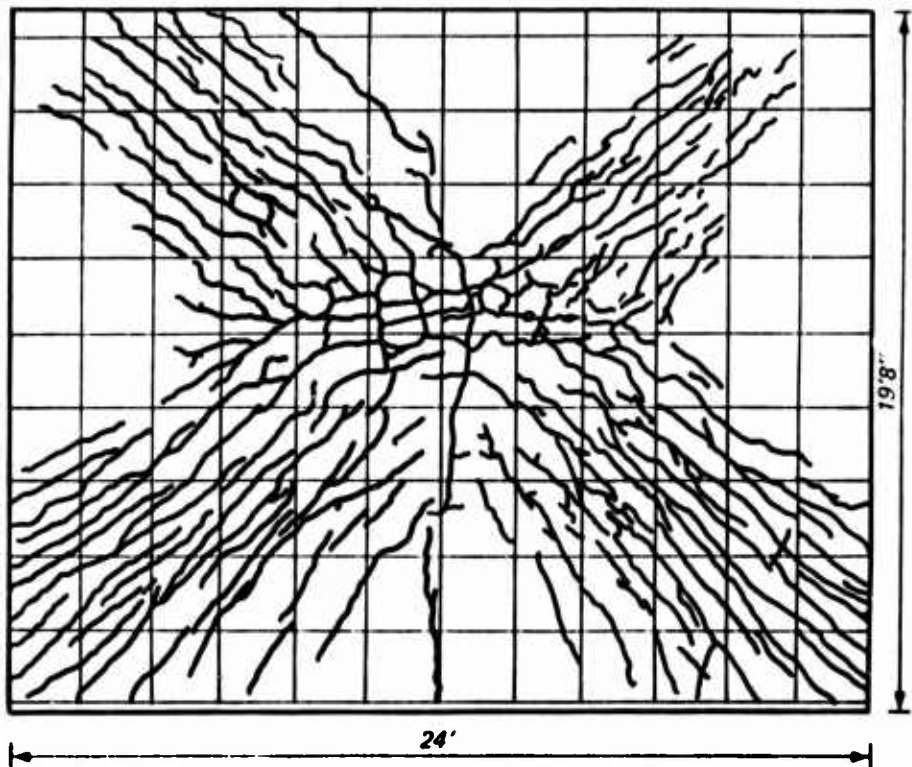
Figure 4.19. Posttest crack pattern on acceptor bay wall.

ALL CRACKS LESS THAN 1 mm WIDE  
GRID IS 2 FEET ON CENTERS

The crack pattern and posttest deflections show that the acceptor bay wall responded in a flexural mode. This is consistent with the load distribution measured on the face of the wall. There was no indication of a punching shear failure.

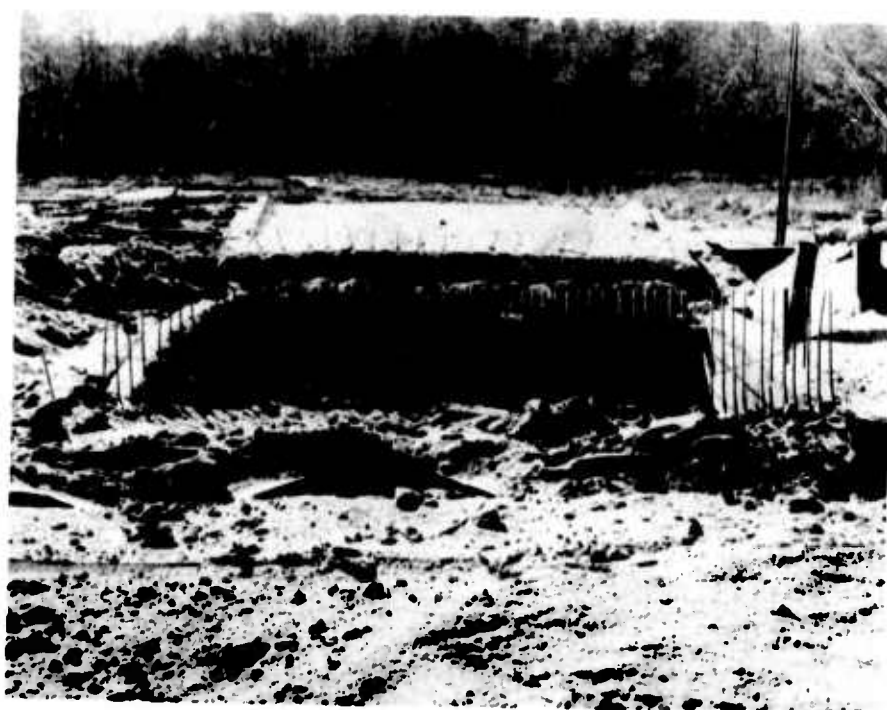
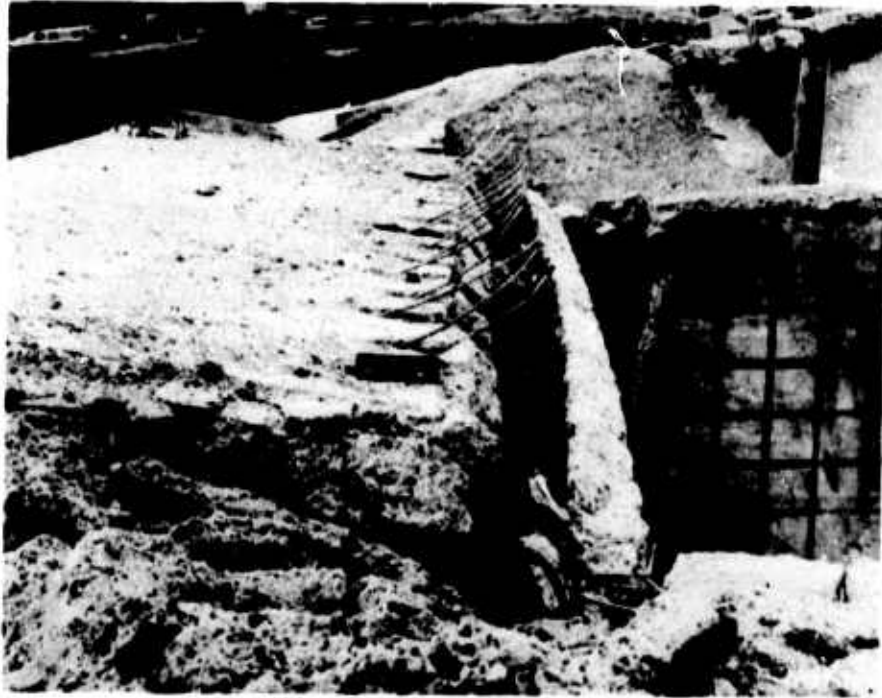
Figure 5.2. Damage to donor bay roof (Sheet 1 of 2).

c. Detail of west half of roof slab.

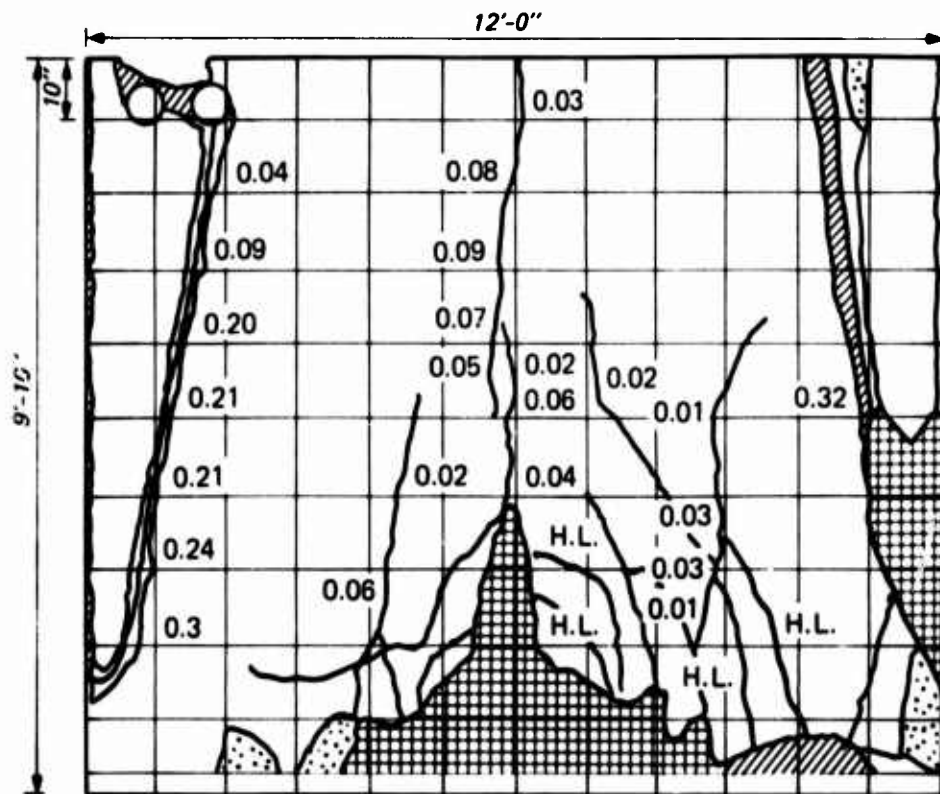
Figure 5.7. Posttest damage to north donor bay wall.

NOTE: CRACK DIMENSIONS IN INCHES

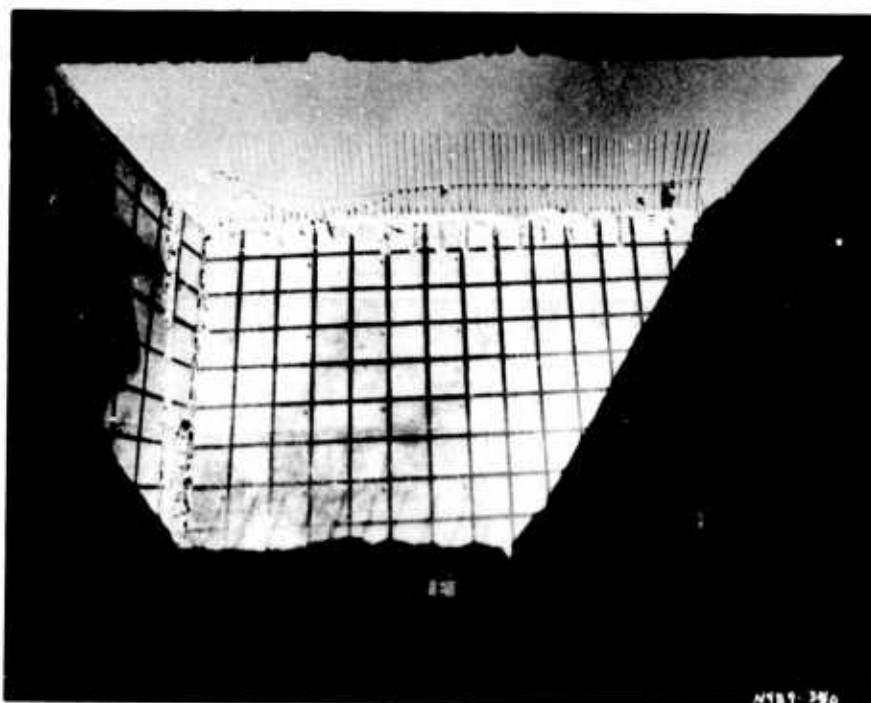
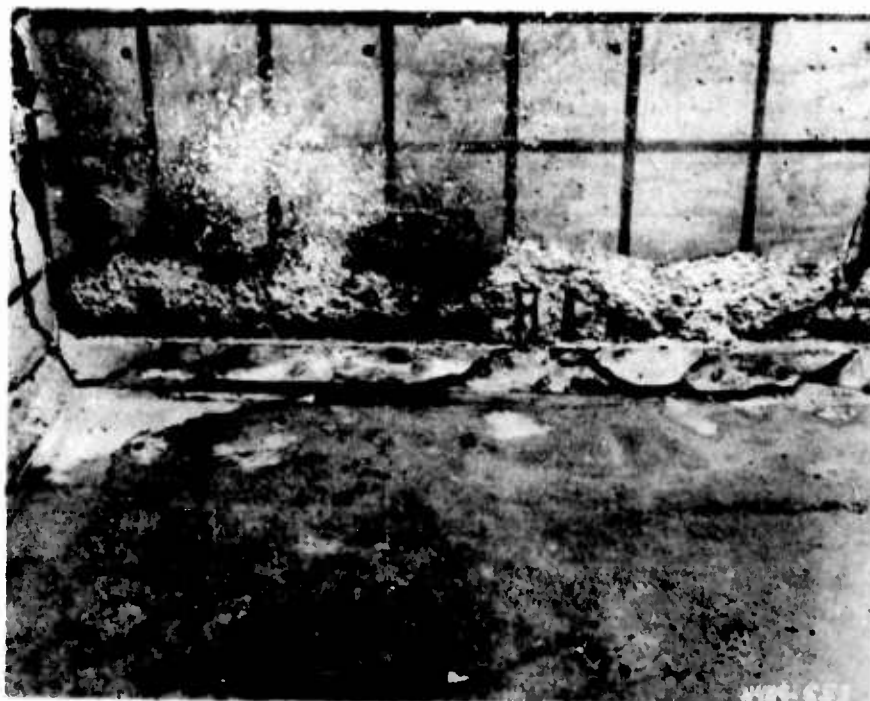
Figure 5.8. Posttest view of donor bay east wall.

b. Damage to lower north corner.

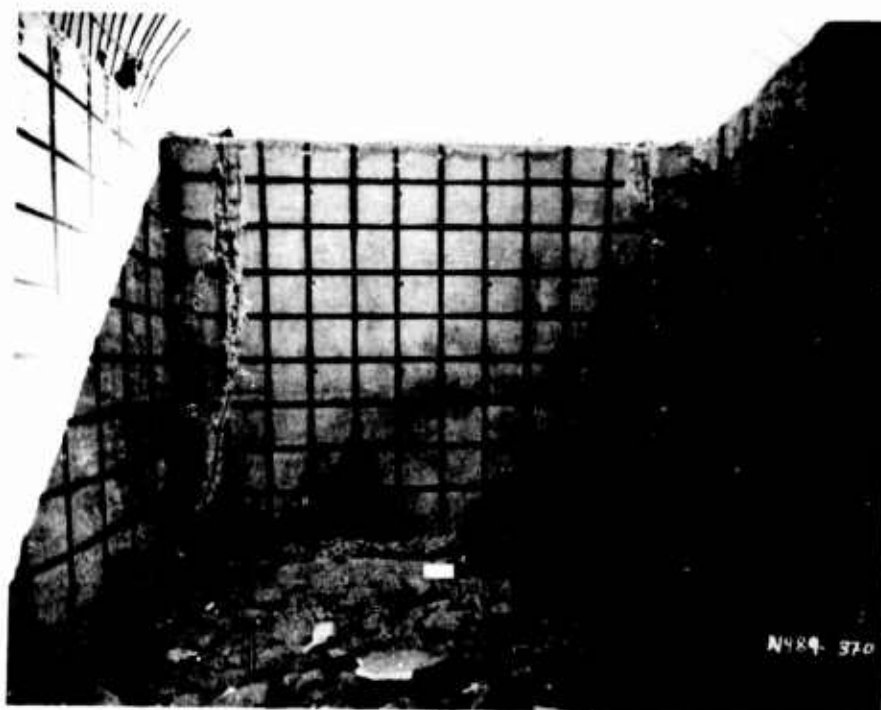
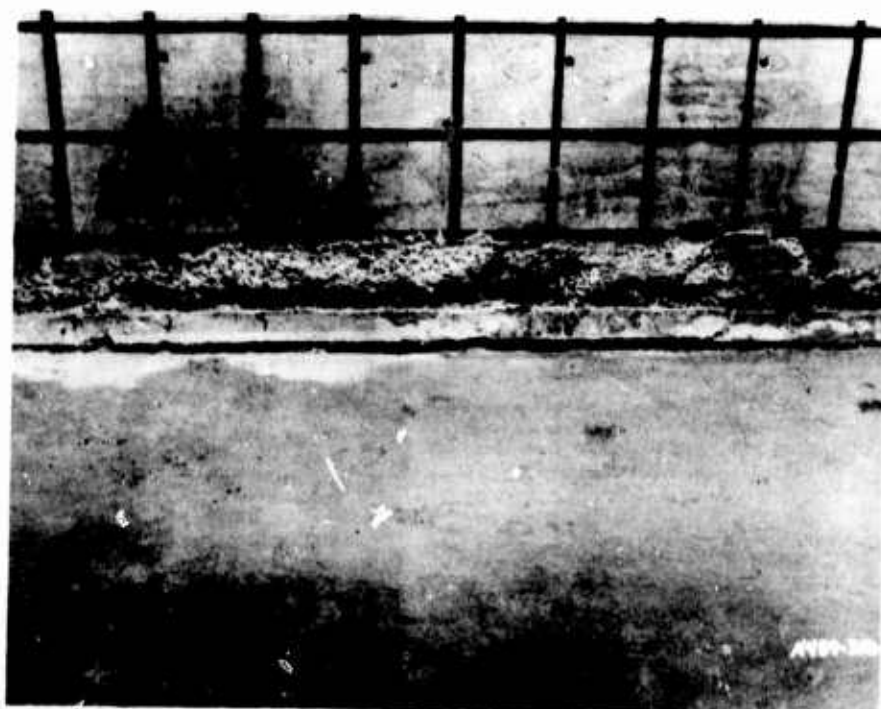
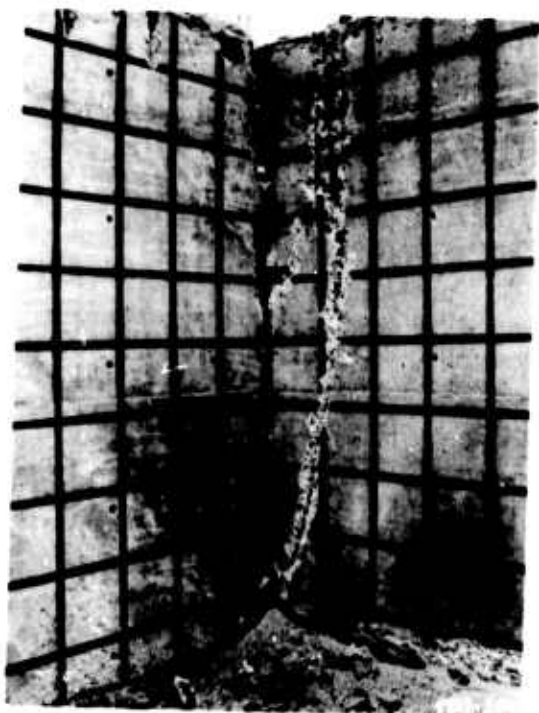
Figure 5.10. Posttest view of south donor bay wall  
(Sheet 1 of 2).

b. Damage to lower edge.

c. Southeast corner.

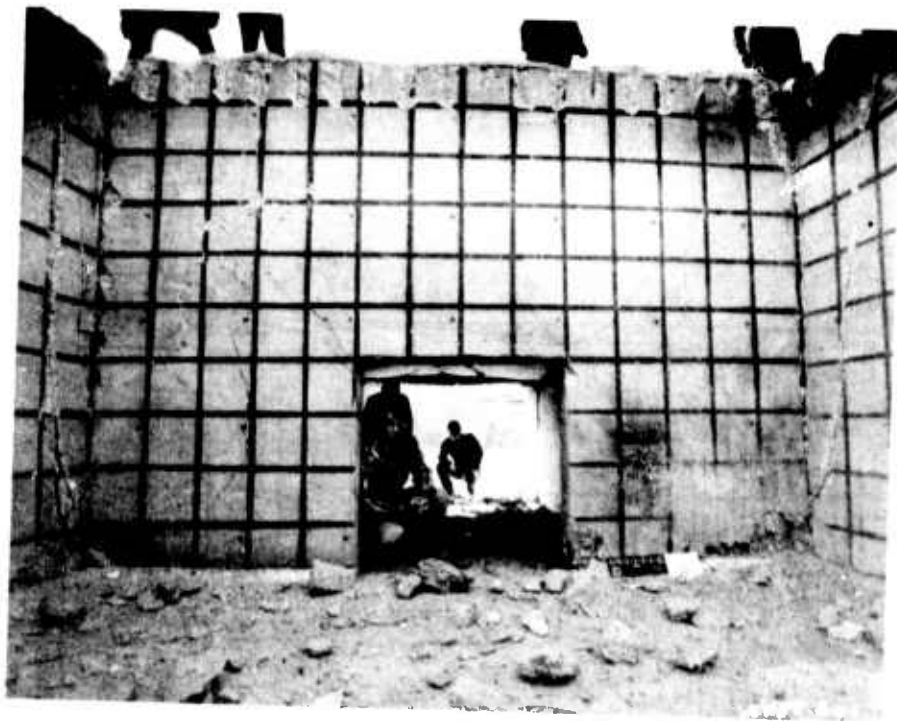
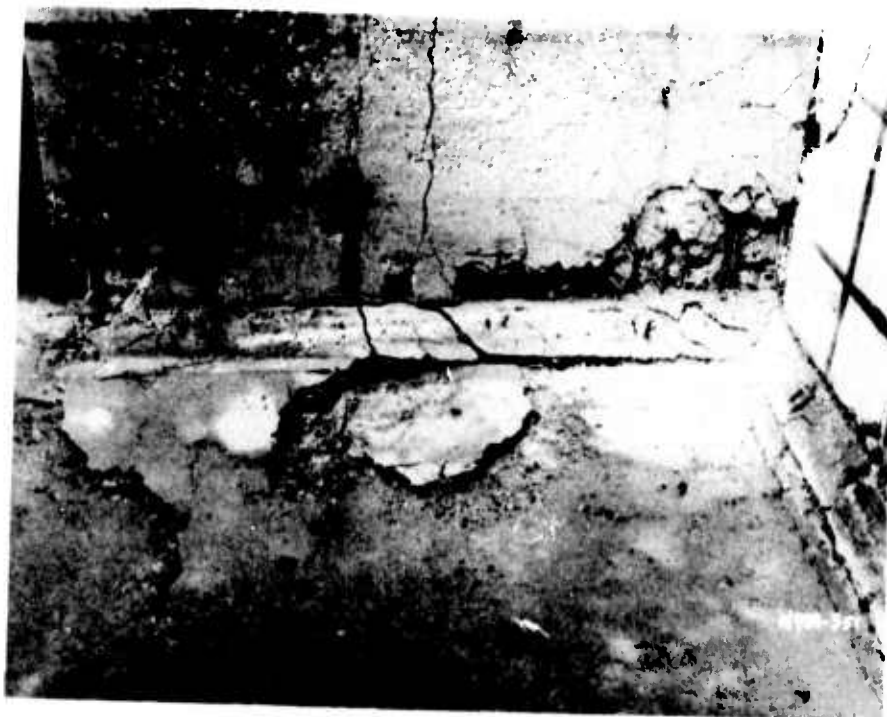
Figure 5.12. Posttest view of west donor bay wall.

b. Damage to lower north corner.

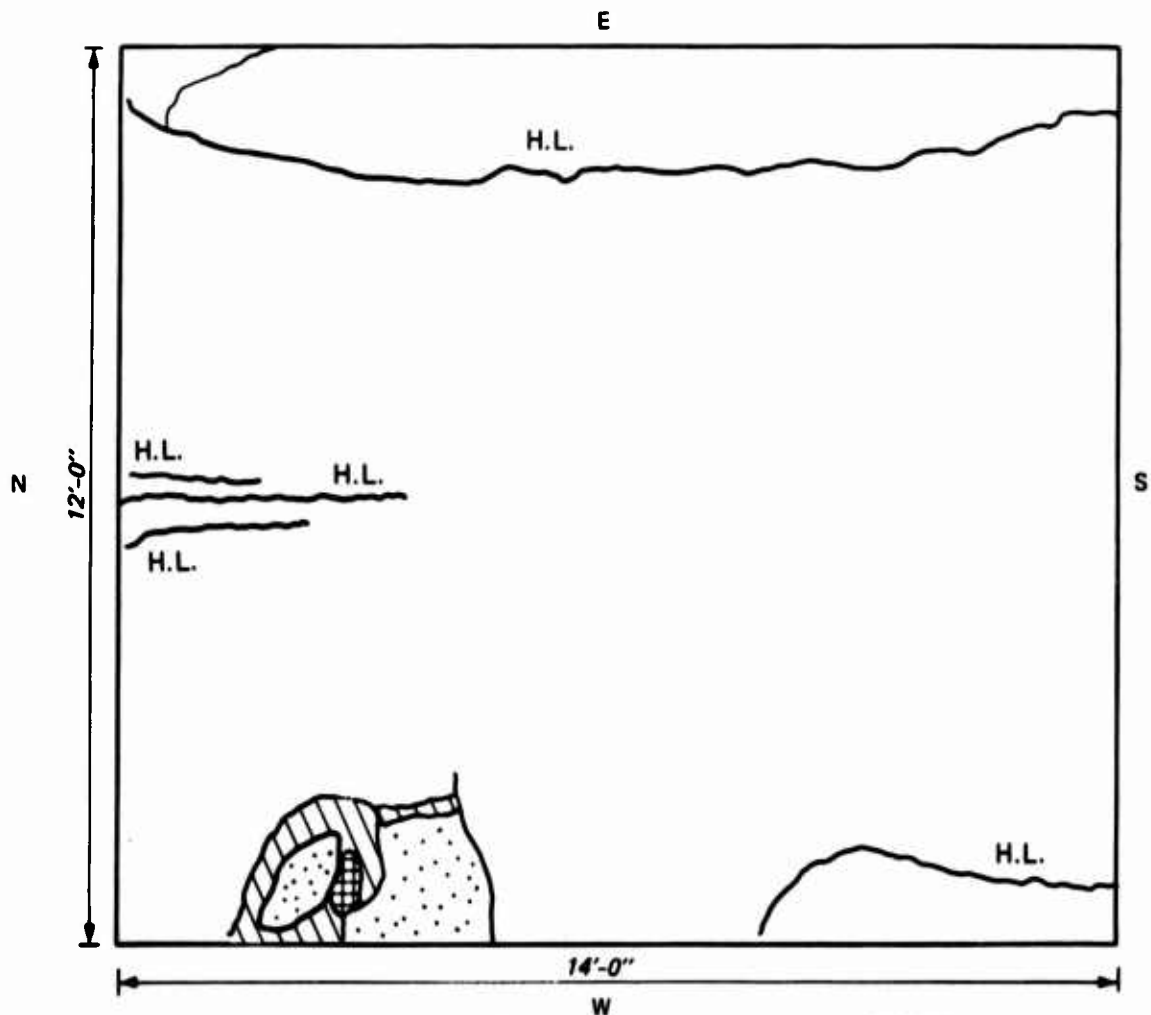
Figure 5.15. Posttest damage to donor bay floor.

NOTE: CRACK DIMENSIONS IN INCHES

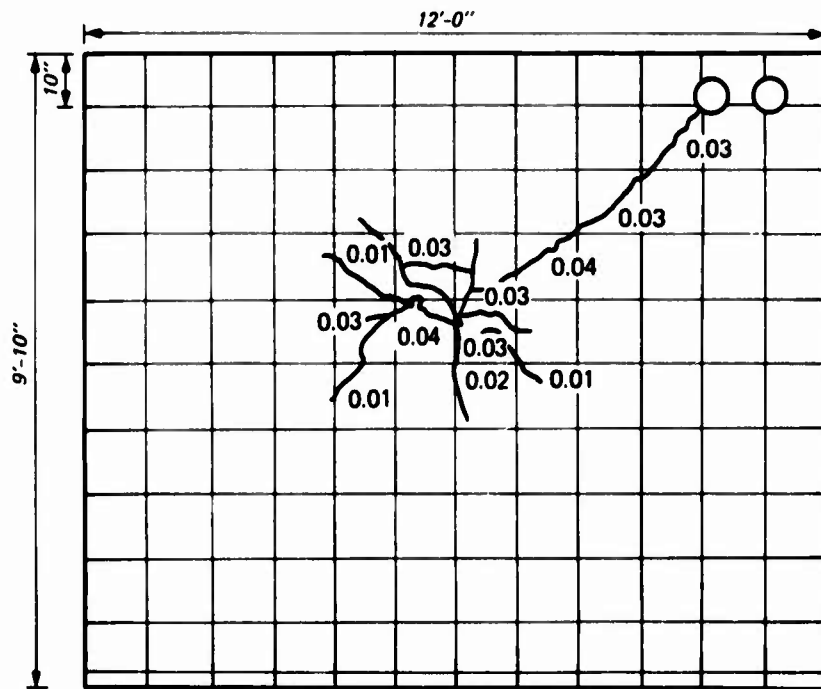
Figure 5.18. Location and size of significant cracks in south acceptor bay wall.

NOTE: CRACK DIMENSIONS IN INCHES

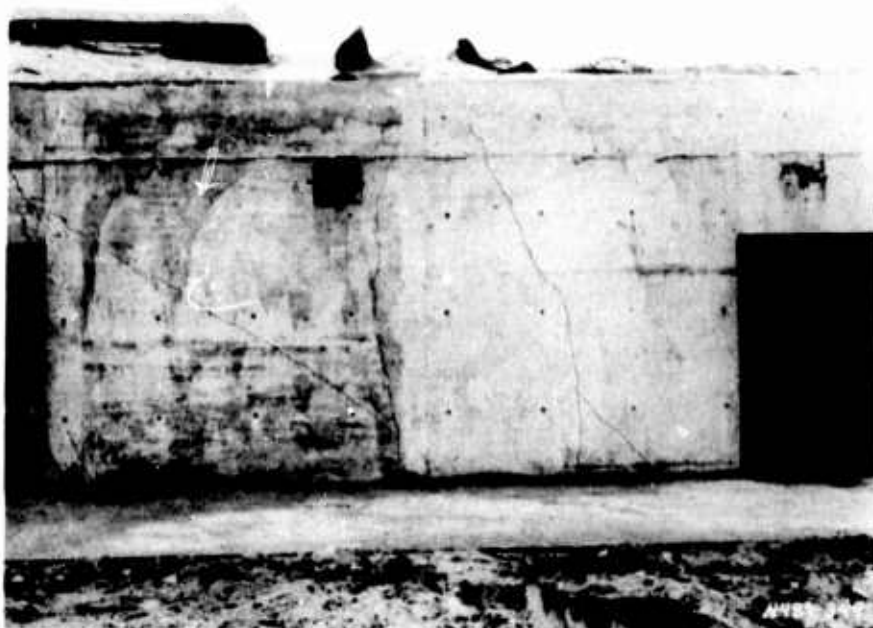
Figure 5.23. Posttest cracking in retaining wall.

b. South of donor air lock.

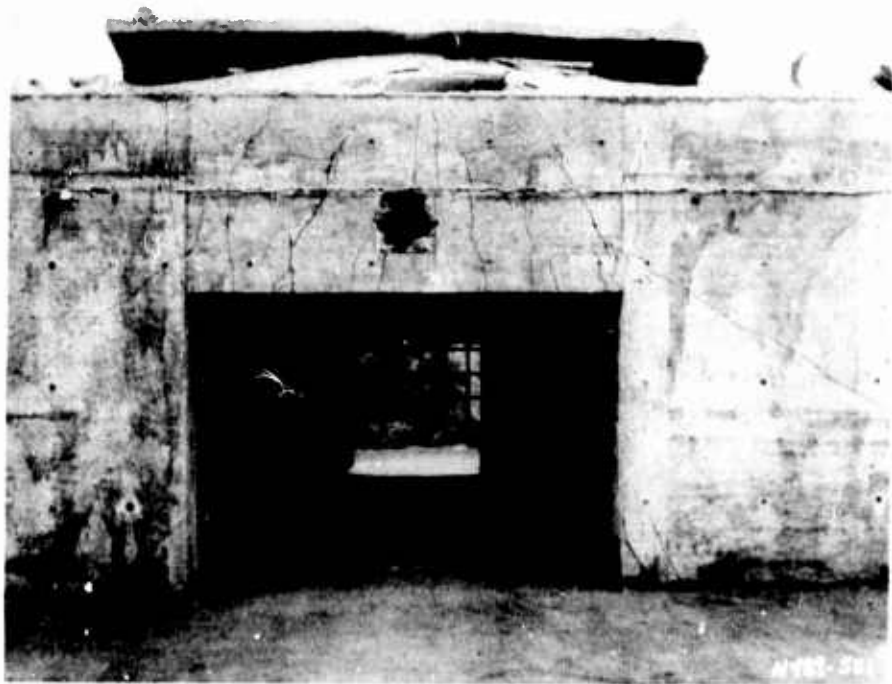
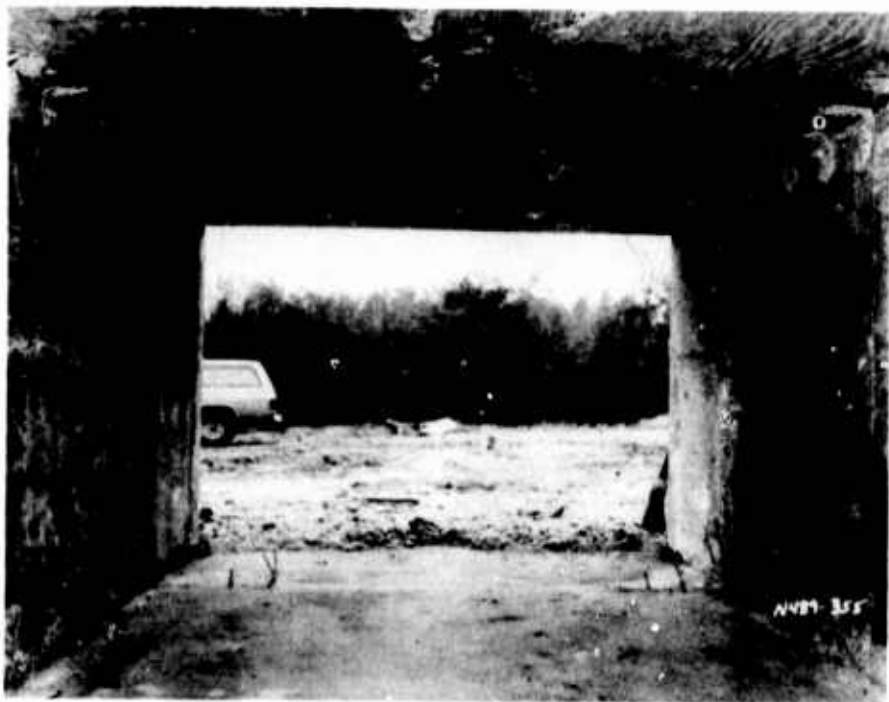
Figure 5.24. Damage to donor bay air lock.

a. Exterior view.

b. Internal view at door bulkhead.

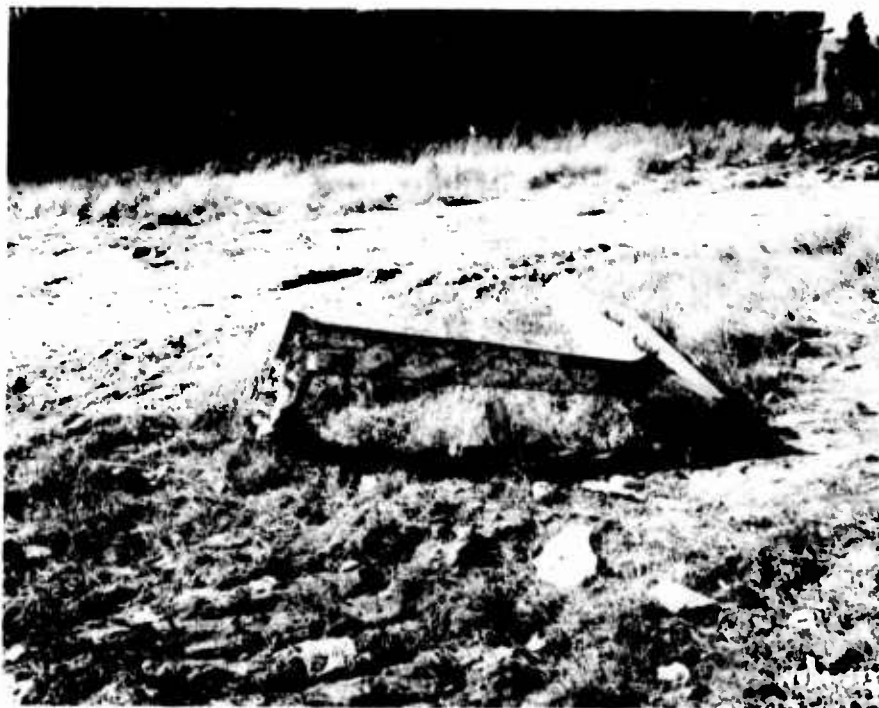
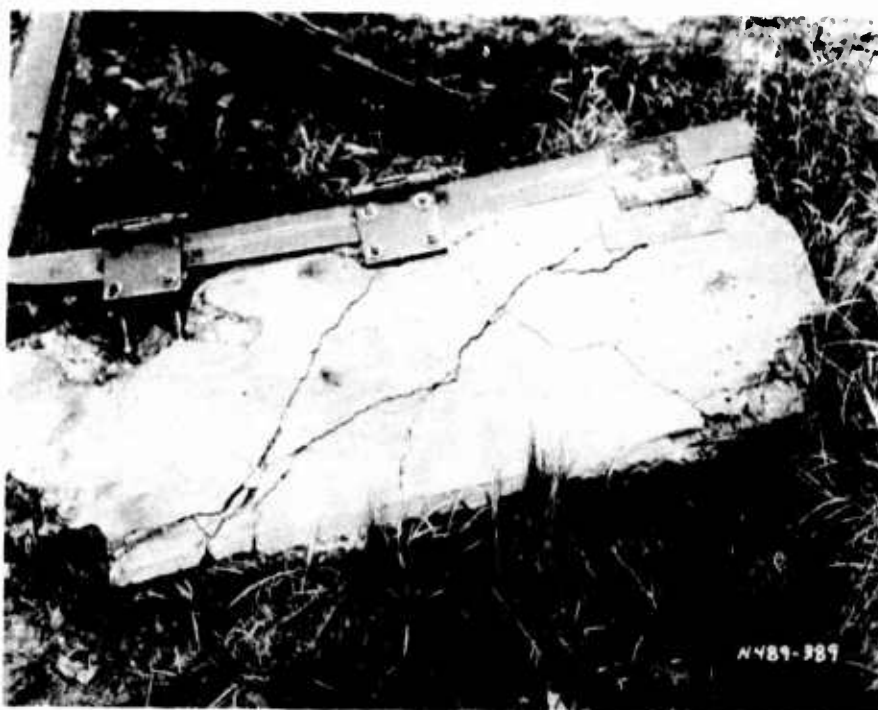
Figure 5.27. Damage to donor bay blast door frame and north part of bulkhead (Sheet 1 of 2).

b. Detail of north side.

c. Detail of south side.
